IAQ ASSESSMENT REPORT

Polk State College – LTB Building
3425 Winter Lake Road
Lakeland, Polk County, Florida 33803

NOVA Project Number: 10106-3024310

Subject: Indoor Air Quality Report – REV1 (10/29/2024)
Polk State College – LTB Building
Lakeland Campus
3425 Winter Lake Road
Lakeland, Florida 33803
NOVA Project No. 10106-3024310

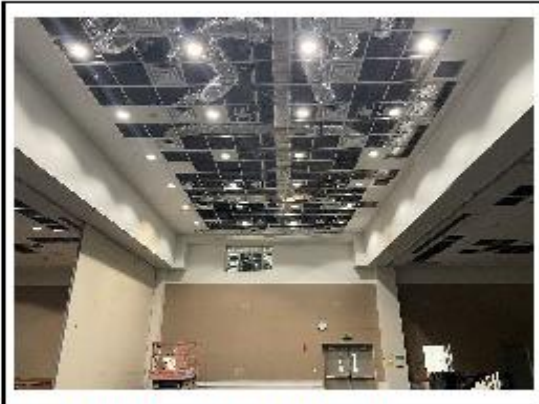
NOVA performed a visual inspection of each of the rooms of the specified by the Client. The NOVA inspector noted visible mold on ceiling tiles in the Auditorium that had been previously removed by staff. Photographs can be found in **Attachment A**

1. Auditorium – Ceiling Tiles removed

1. Proper remediation in the Auditorium and associated Break Room to include HEPA air filtration and disinfecting of floors and duct work in accordance with a Mold Remediation Protocol and Specification document.
2. Continue to replace air filters with MERV 10 rated filters at scheduled times; or after power loss.
3. Remove and replace all stained and/or water damaged ceiling tiles.
4. A final air clearance should be completed to ensure inhabitant health following all remediation and prior to re-installation of building materials.
5. Occupancy should not be allowed to occur until the above items are completed.

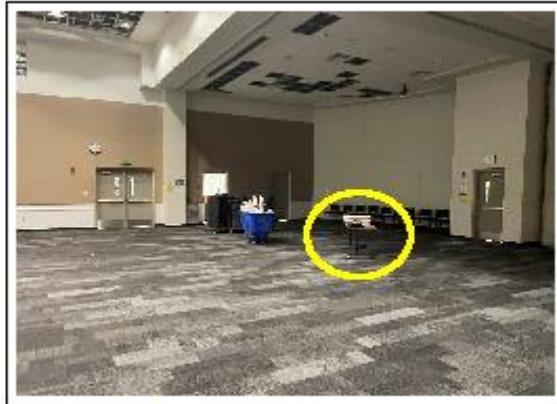
Air sampling results in the Auditorium indicates inadequate air filtration and periods of prolonged moisture. This area has been closed off from occupants as well as the 2nd Floor Breakroom which shares the air handler. These areas are scheduled for Negative Air Filtration and Mold remediation in the near future.

2. Auditorium – ST-1 Location

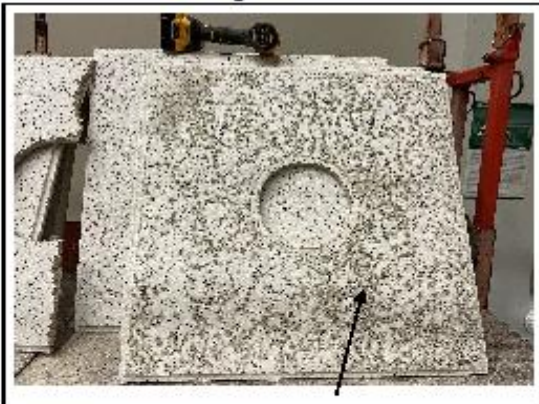
Sample SL-1, collected from the Auditorium on a ceiling tile that was previously removed contained High (>1000 spores of area analyzed) counts of *Cladosporium*. *Cladosporium* produces more than then (10) antigens and is a common cause of extrinsic asthma.

3. Auditorium: Removed Ceiling Tile – SL-1 Location

The Auditorium and associated Break Room should be remediated while under negative air, HEPA filtered. All areas of removal to be enclosed with 4-mil poly walls; HVAC systems off, return air vents sealed. Current, “state of the art” removal techniques are to be utilized to prevent the spread of dusts and spores throughout the area to other adjacent areas that have are at acceptable levels. HEPA filtration units are to be run until final air clearance can be achieved (the units will be turned off during the final air clearance sampling and then turned on following the sampling).

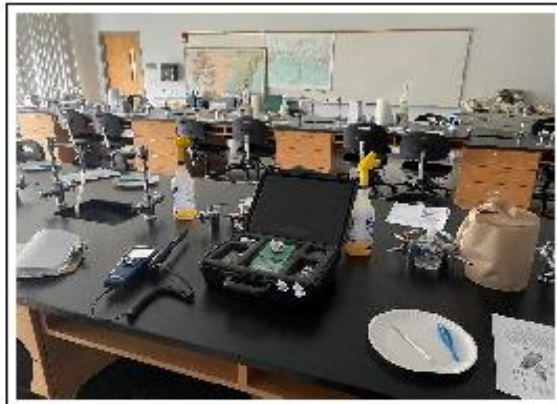
4. Room 2287: ST-3 Location

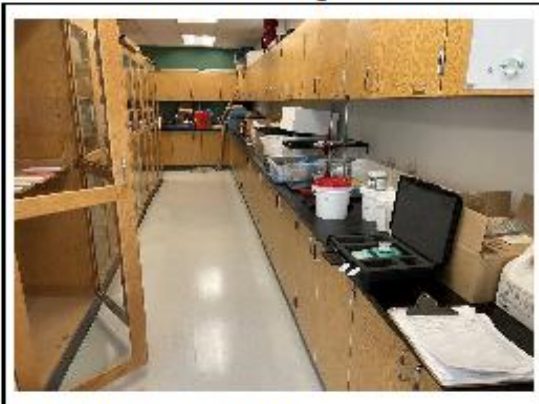
5. Room 2285: ST-7 Location

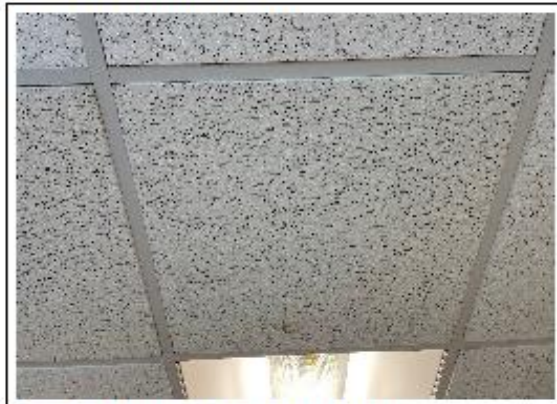
According to information relayed to the NOVA inspector, this area previously experienced positive and negative pressure throughout the building with elevated percent relative humidity (%RH). The NOVA inspector noted stained ceiling tiles in the Auditorium and Room 2285. There were

6. Room 2285: Some ceiling tile staining

1. These areas are safe for occupancy.
2. Continue scheduled normal cleaning and disinfecting of surfaces.
3. Remove and replace all stained and/or water damaged ceiling tiles.
4. Continue to replace air filters with MERV 10 rated filters at scheduled times; or after power loss.
